Figure 2. The ArEcVideo system concept.

Flow Chart of the E-Commerce Video Editing Tool

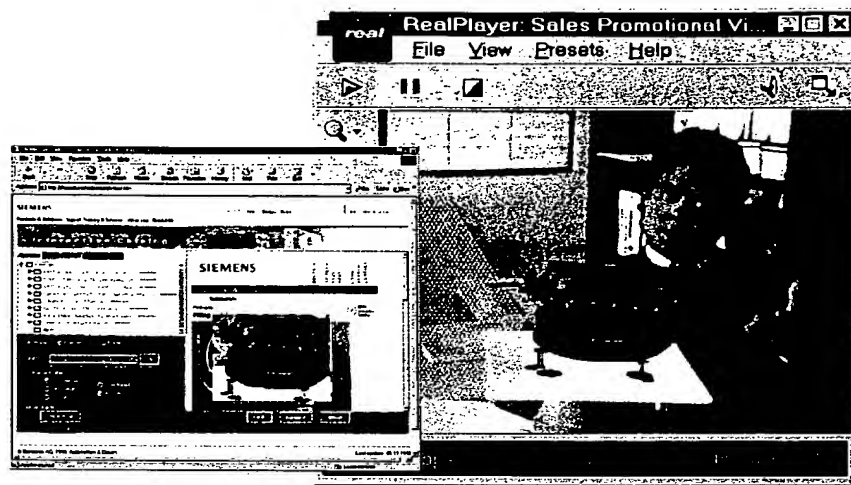
Figure 1. An image from a piece of example ArEcVideo created using our ArEcVideo tool.

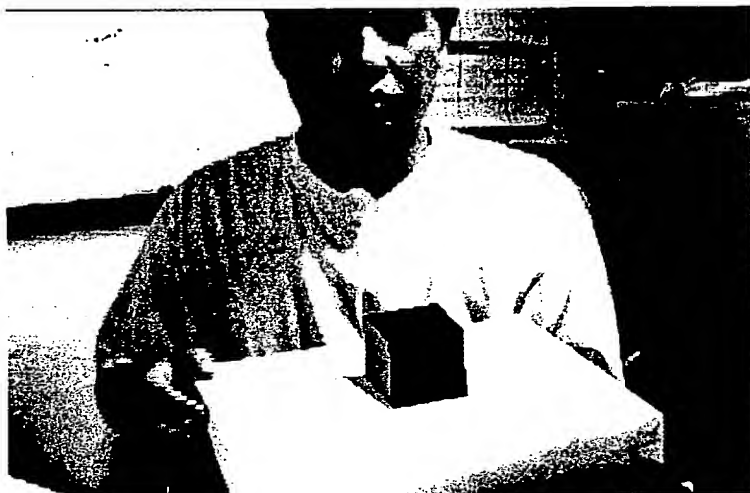
Figure 6. A color cube augmented on top of the model plane using OpenGL rendering with a fake shadow.
